# JS Davidson

## Aerial Roof Condition Assessment

### Industrial Facility Roof Inspection Report

Ref: **VF-JSD-BOURNE-B001**

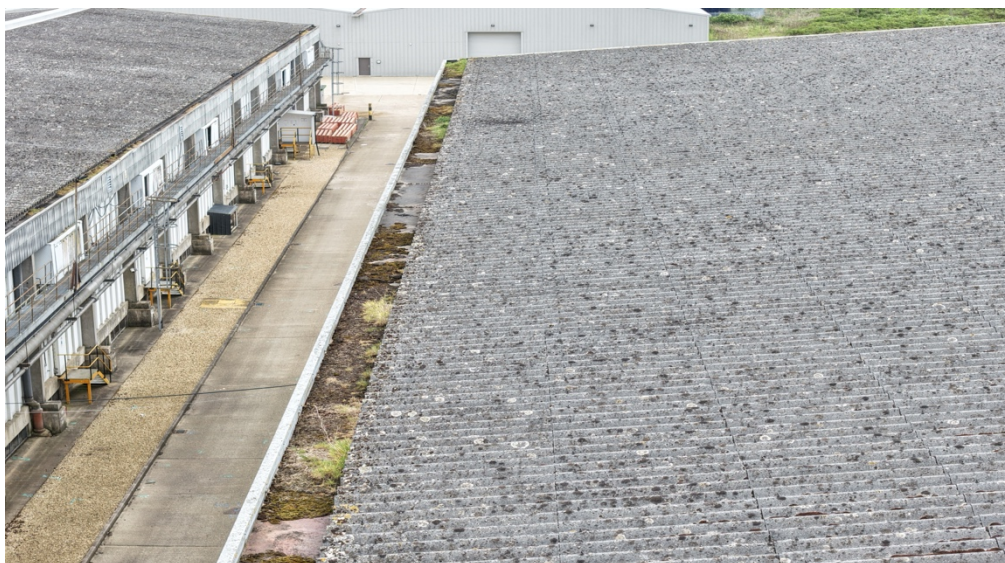
Zone 1 appears visually stable in terms of broad roof sheet alignment. However, the amount of biological growth and debris present across the roof surface indicates that routine maintenance is required. Attention should be given to drainage paths, gutters, roof edges and valley areas where moss and debris are retaining moisture.

*Figure 8. Corrugated roof sheet condition / Drainage issue*

- Clear moss and debris from roof sheet valleys.
- Inspect drainage outlets and gutters.
- Clean and inspect perimeter cappings.
- Check roof sheet laps and fixings at close range.
- Monitor areas of heavier staining for possible moisture retention.

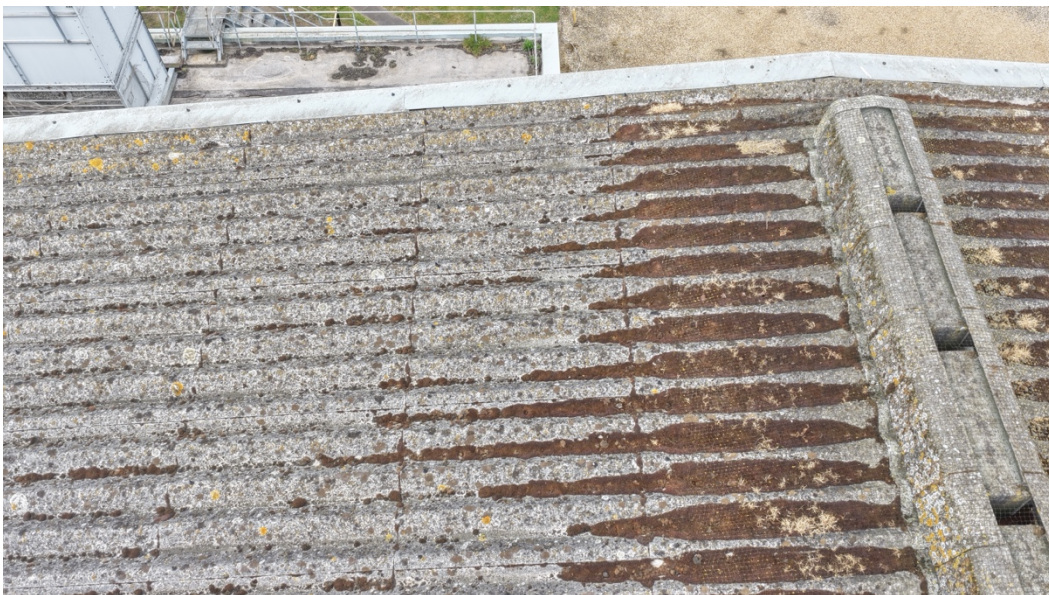
Zone 2 shows a higher concentration of maintenance-related issues than a clean uninterrupted roof field. The junction between the corrugated roof covering, cladding base and associated drainage channel appears particularly vulnerable due to moss, sediment and vegetation growth. These conditions are likely to reduce drainage efficiency and may increase the risk of water retention at roof details.

*Figure 9. Biological growth*

- Clear vegetation and sediment from abutment gutters and drainage channels.
- Inspect roof-to-wall flashing interfaces.
- Check capping fixings and edge details.
- Treat localised corrosion to brackets, pipework and fixings.
- Remove debris from roof sheet valleys.
- Inspect areas beneath service pipework where access may be restricted.

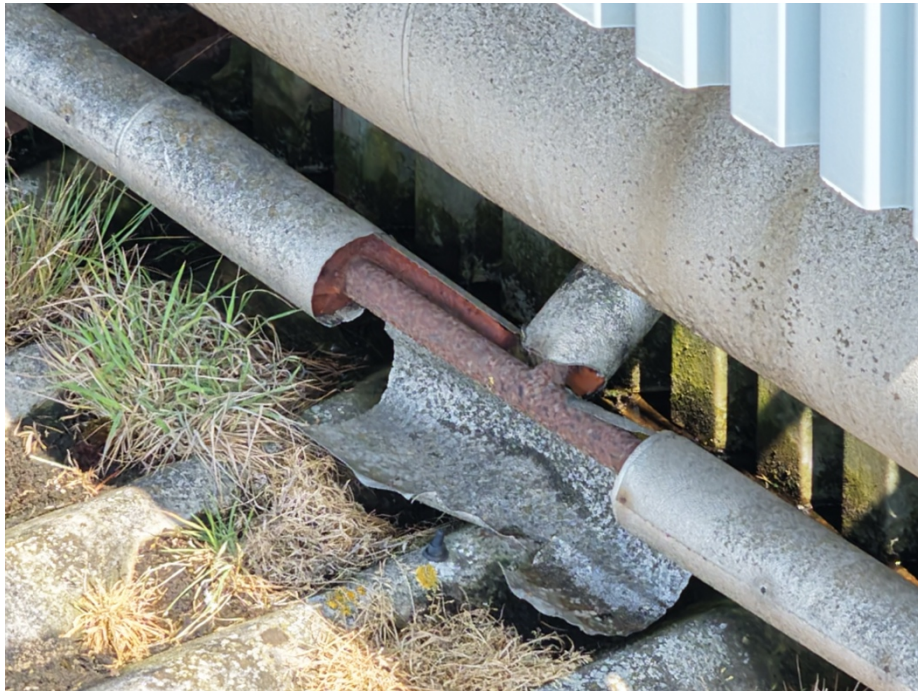
Zone 3 is a priority maintenance area because it contains several interacting risk factors: roof junctions, service pipework, support steelwork, restricted access areas and vegetation growth. The roof-to-wall interface appears to be collecting debris and moisture, which may accelerate corrosion and deterioration of adjacent materials.

*Figure 10. Corroded / Exposed pipework*

- Remove all vegetation and organic debris from the joint flashing area.
- Inspect the abutment flashing and drainage channel at close range.
- Clean beneath pipework and access steelwork.
- Treat corrosion to service supports and metalwork.
- Repair or replace damaged pipe insulation.
- Remove loose cables or redundant wiring from the roof surface.
- Carry out close inspection of corrugated sheets where surface cracking is visible.

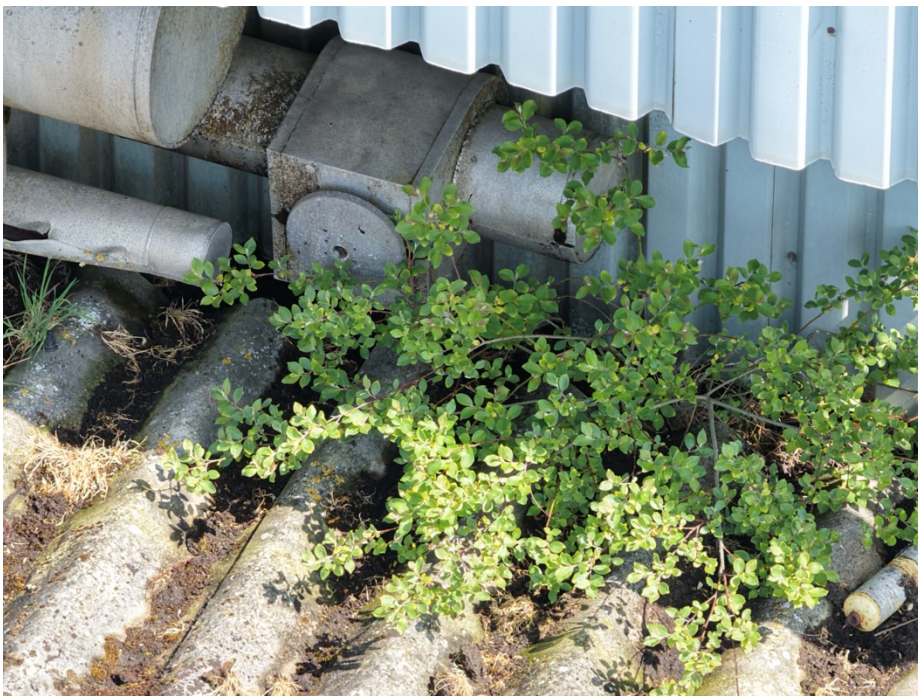
*Figure 11. Vegetation Growth*

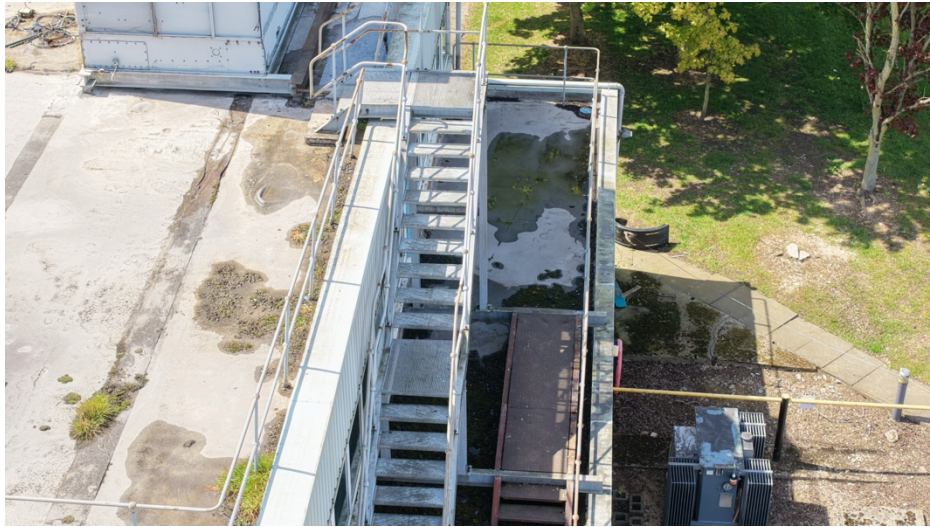
Zone 4 is the highest-priority maintenance area identified during the inspection. The concentration of standing water, vegetation, redundant materials, corrosion and plant equipment increases the risk of blocked drainage, localised water ingress, slip/trip hazards and progressive deterioration of deck waterproofing.

*Figure 12. Water ponding*

- Remove loose redundant pipes, cables and scrap materials from the plant deck.
- Clear moss and vegetation from deck edges, plant bases and stair areas.
- Investigate drainage falls and outlets causing standing water.
- Clean contaminated deck surfaces.
- Inspect plant bases, rooflights and service penetrations.
- Treat corrosion to handrails, pipework, brackets and fixings.
- Undertake close-range waterproofing inspection to identify splits, cracks or failed laps.

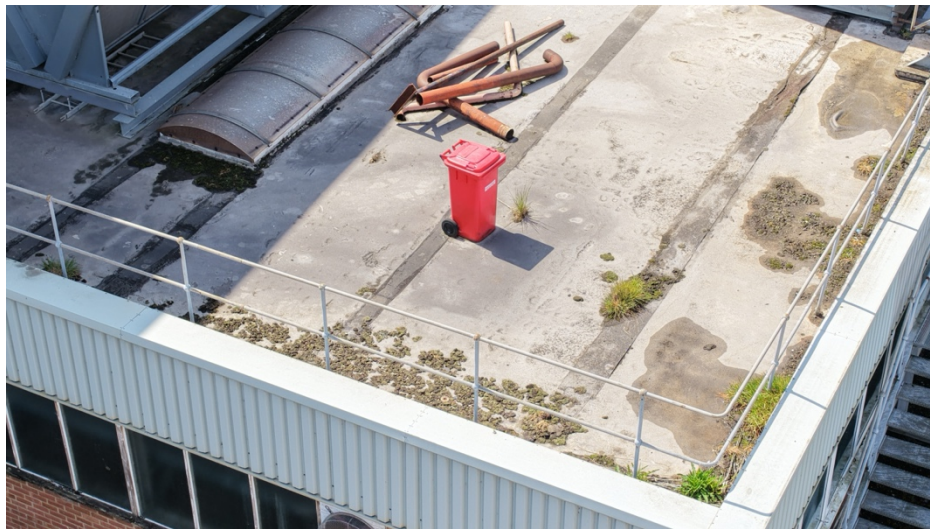
The presence of loose pipes, cables and redundant service components should be addressed as part of roof housekeeping. The standing water suggests that drainage falls, outlets or surface levels should be reviewed.

*Figure 13. Biological Growth / Loose pipework*

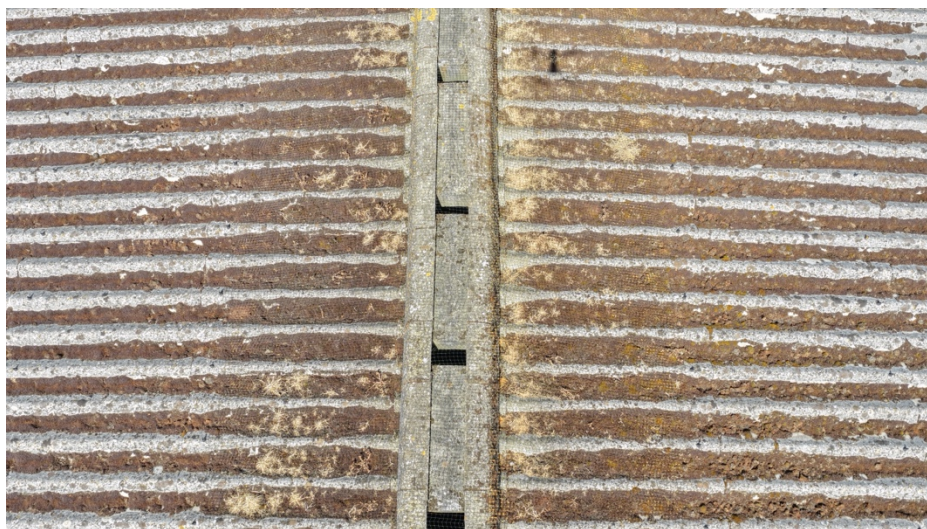
### Defect 01 – Widespread Biological Growth and Organic Debris to Corrugated Roof Sheets

Moss, lichen and organic debris were observed across the corrugated roof sheets. The debris is concentrated within roof sheet valleys and along sheet laps.

The growth appears consistent with long-term environmental exposure and damp retention. While this does not confirm immediate roof failure, organic material can retain moisture against the roof covering and may contribute to progressive surface deterioration.

*Figure 14. Widespread organic debris retained within corrugated roof sheet valleys.*

Clear loose moss and organic debris using an appropriate non-damaging method. Inspect the roof sheets after cleaning to identify any concealed cracks, delamination, damaged fixings or lap defects.

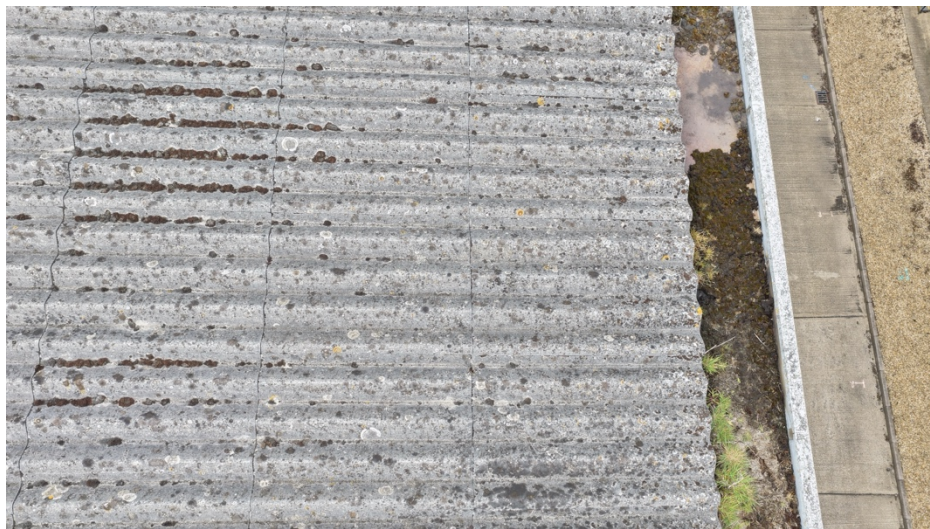
**Defect 02 – Blocked / Restricted Drainage Channels at Roof Edges and Abutments.**

Restricted drainage can allow water to remain at roof junctions for extended periods. This increases the risk of water ingress and corrosion to adjacent metal components.

*Figure 15. Restricted drainage channel with moss, sediment and vegetation at the roof-to-wall junction.*

Clear all drainage channels, abutment gutters and edge details. Check outlet locations, falls and water discharge routes. Inspect flashings and capping joints once the area is clear.

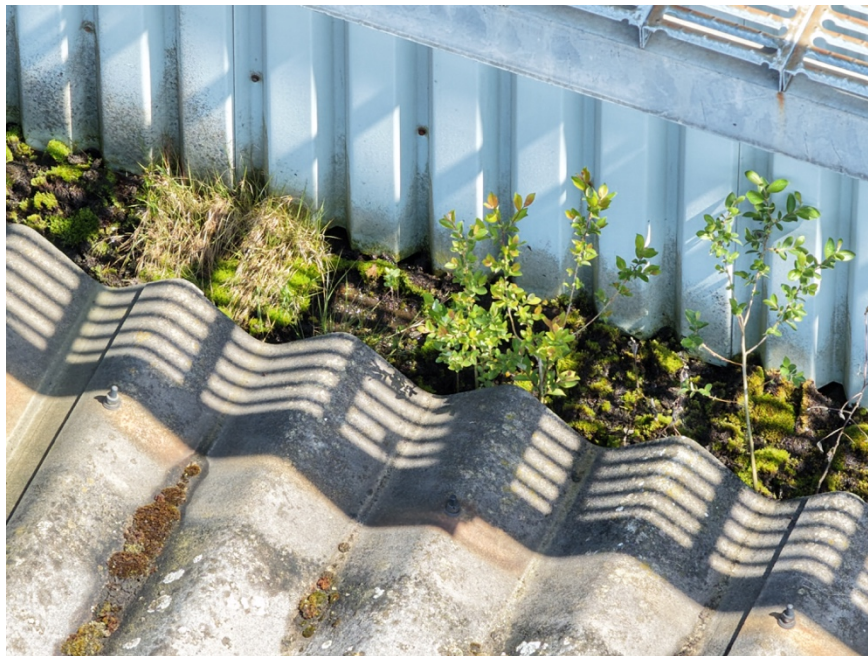
**Defect 03 – Vegetation Growth at Joint Flashing / Roof-to-Wall Interfaces.**

Substantial moss, grass and small vegetation growth were observed along the joint flashing and roof-to-wall interface. Vegetation is present behind cladding bases and beneath service pipework.

This indicates persistent moisture retention and accumulated sediment. The growth may be obstructing water flow and could be concealing deterioration of the flashing detail.

*Figure 16. Established vegetation growth at the joint flashing and cladding base interface.*

Remove vegetation and sediment from the junction. Inspect the flashing line, cladding base, gutter channel and any lap joints. Repair or reseal defective areas as required.

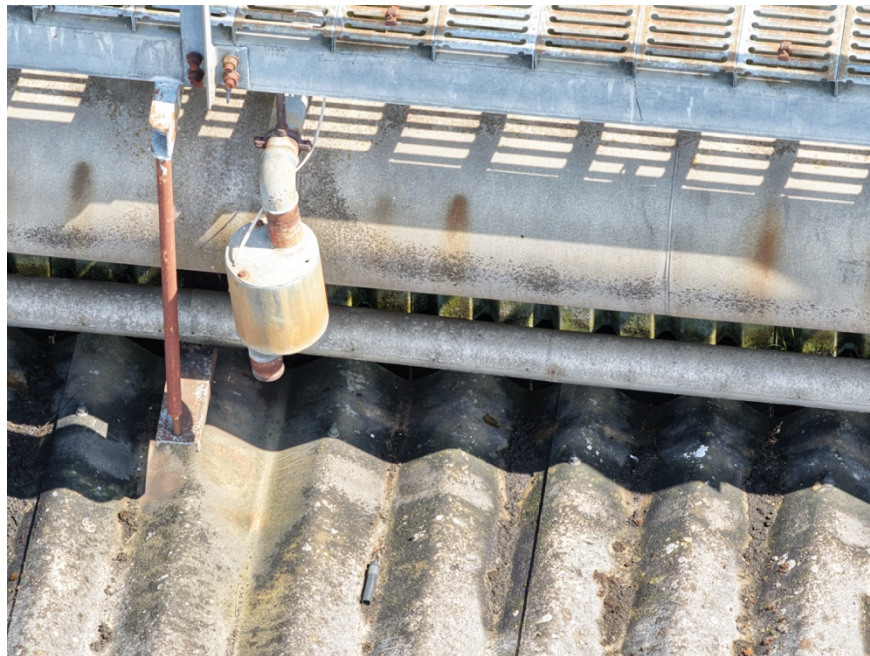
### Defect 04 – Corrosion to Roof-Mounted Pipework, Supports and Fixings

Corrosion was observed to service pipework, brackets, bolts, support steelwork, grating fixings and plant-related metal components. In several areas, staining from rusted components is visible on adjacent surfaces.

The corrosion appears localised but widespread across exposed metal elements. This is typical of long-term external exposure, particularly where water is retained or drainage is restricted.

*Figure 17. Corroded pipe support / service detail with deteriorated metal components.*

Carry out close-range inspection of corroded supports, brackets and fixings. Clean, treat and repaint corroded metalwork where serviceable. Replace heavily corroded components.

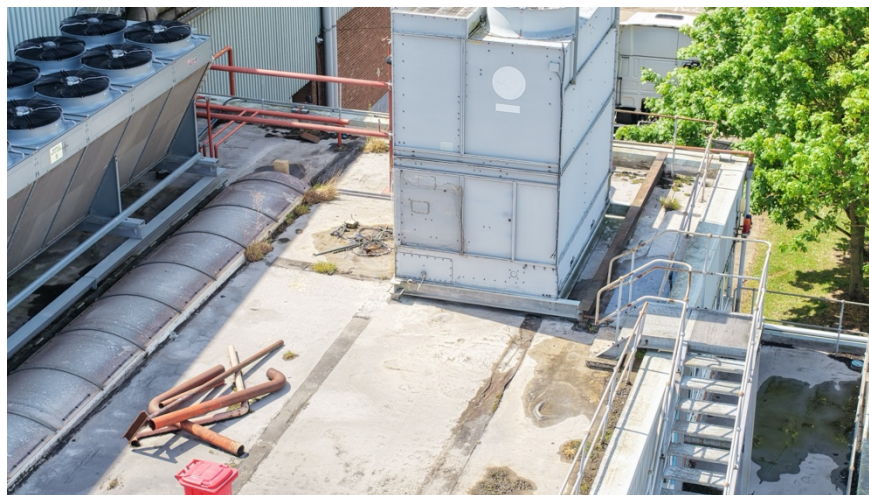
**Defect 05 – Loose / Redundant Service Materials and Debris on Plant Deck****Location:** Zone 4 Plant Area**Priority:** High**Risk Category:** Trip hazard / drainage obstruction / roof surface damage

Loose redundant pipe sections, metal parts and coiled service cables were observed on the plant deck. Several items appear to be resting directly on the roof surface.

Loose materials can damage waterproofing, obstruct drainage, create trip hazards and become displaced during high winds.

*Figure 18 Loose redundant pipe sections and materials stored on the plant deck.*

Remove all redundant materials and loose debris from the plant deck. Review whether any retained materials are required. Store necessary items off the roof surface or remove them from site.

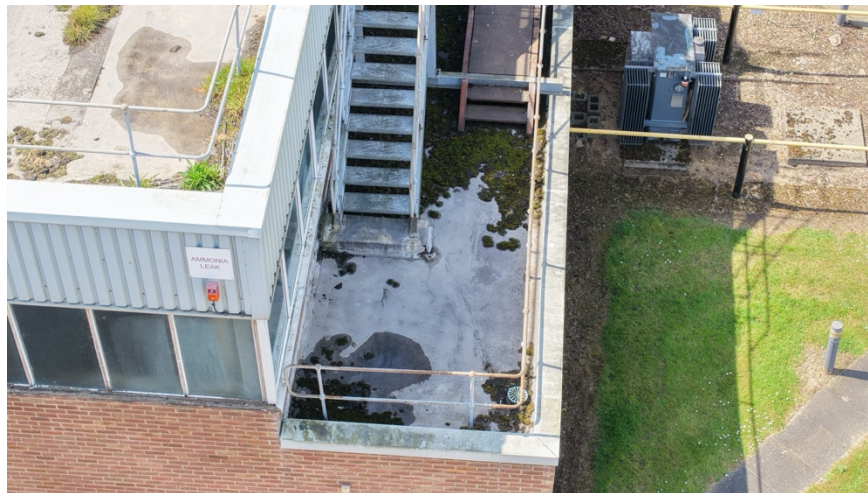
### Defect 06 – Standing Water / Ponding to Flat Plant Deck

Standing water and ponding were observed on the flat plant deck, particularly near access routes, stair landings and plant equipment areas.

Ponding indicates restricted drainage, insufficient falls, blocked outlets or surface settlement. Standing water can accelerate membrane deterioration and increase slip risk.

*Figure 19. Standing water and moss accumulation around the access stair and lower plant deck area.*

Clear drainage outlets and channels. Undertake a close-range deck survey to confirm falls, outlet condition and membrane integrity. Repair local low spots or defective waterproofing as required

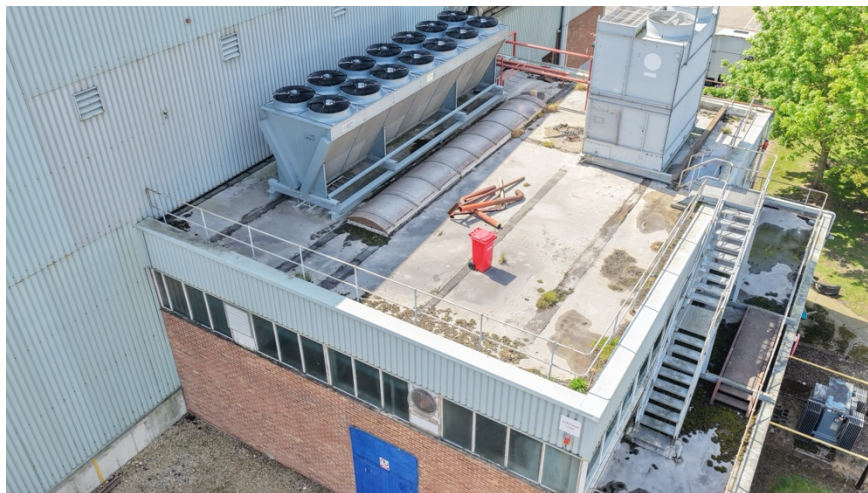
### Defect 07 – Vegetation Growth and Moss Accumulation to Plant Deck Edges

This indicates that dirt and moisture are being retained on the deck surface. Growth at edges and plant bases can conceal defects and restrict water movement.

*Figure 20. Vegetation and moss growth along plant deck edges and drainage areas.*

Remove vegetation and sediment. Inspect waterproofing, upstands, plant bases and handrail penetrations after clearance. Improve maintenance cleaning frequency.

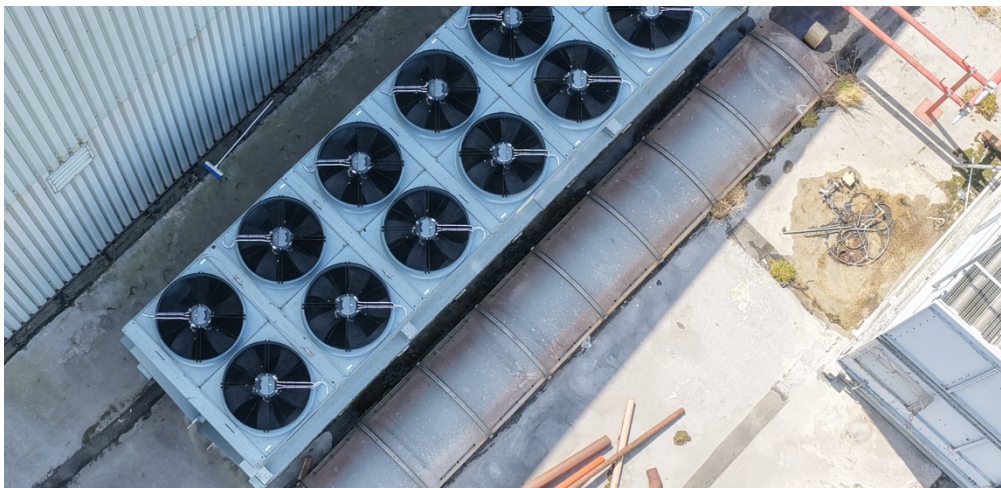
## Defect 08 – Weathered / Stained Rooflights and Adjacent Drainage Areas

The barrel-vaulted translucent rooflight units show surface staining, weathering and dirt accumulation around their bases. Moss and debris are present nearby.

Rooflights and their upstands are common water ingress risk points. Debris around rooflight bases may restrict drainage and hold moisture against the waterproofing.

*Figure 21. Weathered barrel rooflights with staining and moss/debris accumulation around adjacent junctions.*

Clean rooflight surfaces and surrounding drainage areas. Inspect seals, fixings, upstands and waterproofing laps at close range.

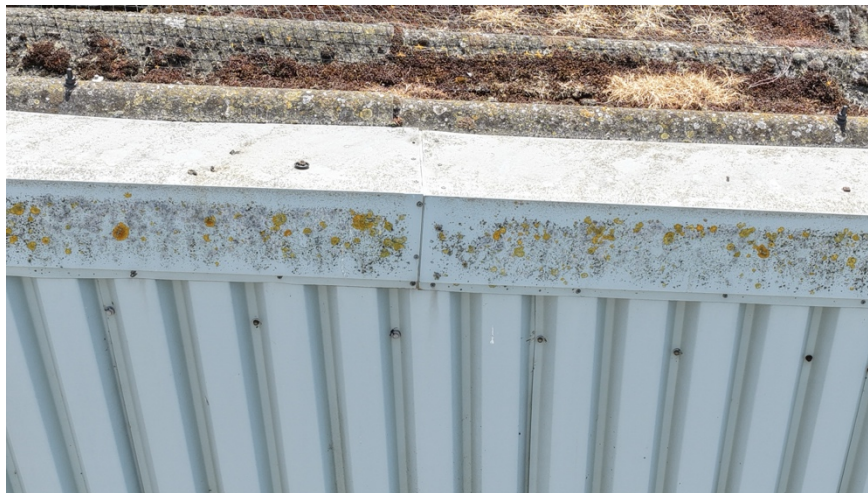
### Defect 09 – Weathering and Biological Contamination to Perimeter Cappings

Perimeter cappings show surface contamination, lichen growth and weathering. Some areas show staining at joints and fixings.

Cappings protect exposed roof edges and wall head details. If fixings, joints or overlaps deteriorate, water may enter the roof edge construction or track into cladding interfaces.

*Figure 22. Biological growth, lichen and staining to perimeter capping.*

Clean cappings, inspect fixings and check laps/joints. Replace missing or corroded fixings and reseal defective joints where required.

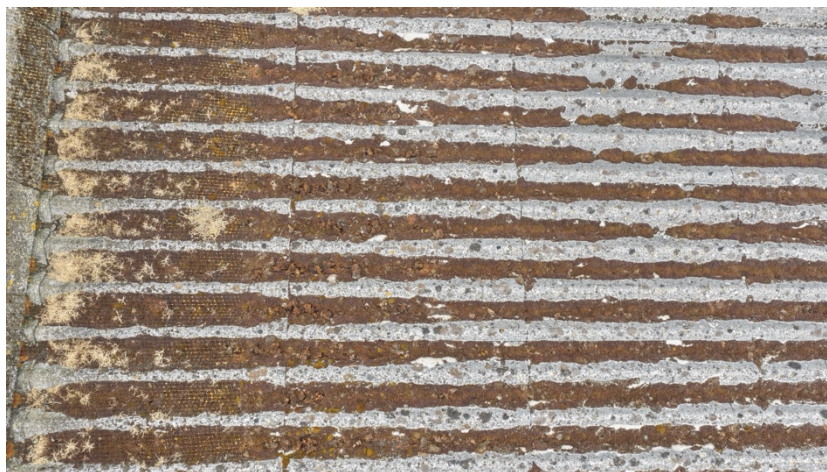
**Defect 10 – Localised Corrugated Roof Sheet Surface Deterioration / Cracking Requiring Confirmation**

Several corrugated roof sheets show surface weathering, staining and localised line features that may indicate cracking or surface deterioration. These require confirmation by close inspection because aerial imagery alone cannot determine depth, structural significance or material condition.

*Figure 23. Localised roof sheet surface deterioration*

After cleaning, undertake close-range inspection of suspect sheet areas.

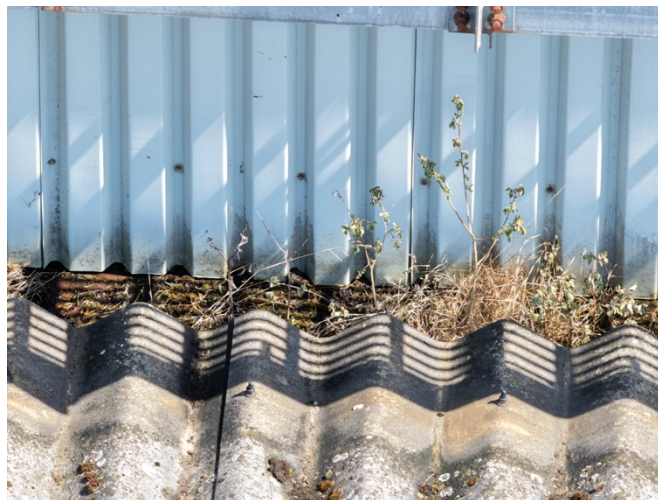
*Figure 24. Dense vegetation around service penetrations indicating long-term moisture and sediment retention.*

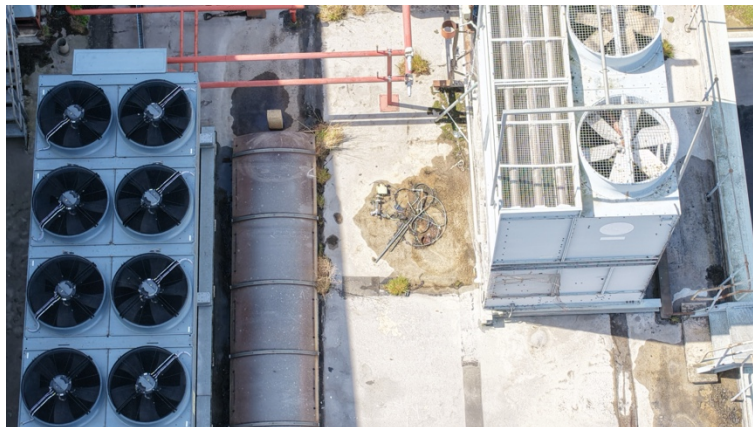
The plant deck contains loose redundant materials, cables, pipes and debris. This increases maintenance risk and may obstruct drainage or damage waterproofing.

*Figure 25. Loose cables, redundant materials and staining around plant equipment.*

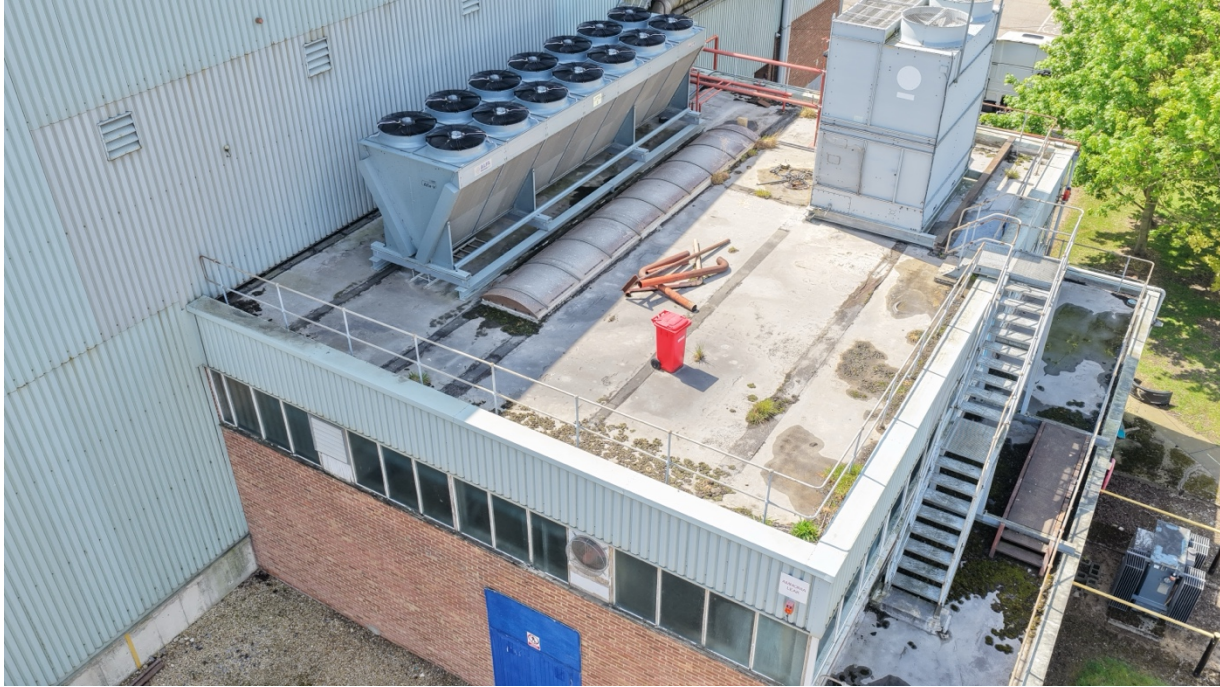
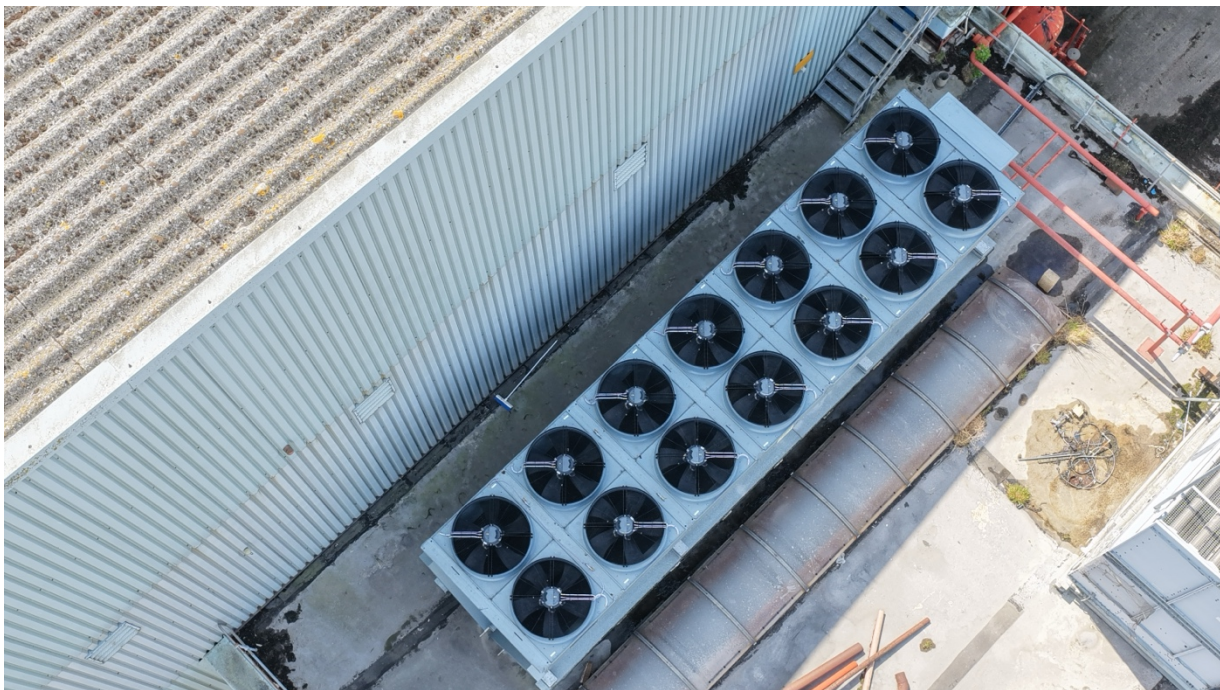
**ZONE 4**

| <b>Defect Ref</b> | <b>Defect Description</b> | <b>Priority</b> |
|---|---|---|
| <b>Z4-D09</b> | General plant deck surface deterioration, staining and ageing of waterproofing finishes. | Medium |
| <b>Z4-D10</b> | Potential slip / trip hazards due to standing water, moss growth and loose materials. | High |
