Vista Fly

ROOF INSPECTION REPORT

02 March 2026

A full aerial and internal visual inspection were conducted of the industrial roof system divided into Zones A–D, including the inter-unit valley joint.

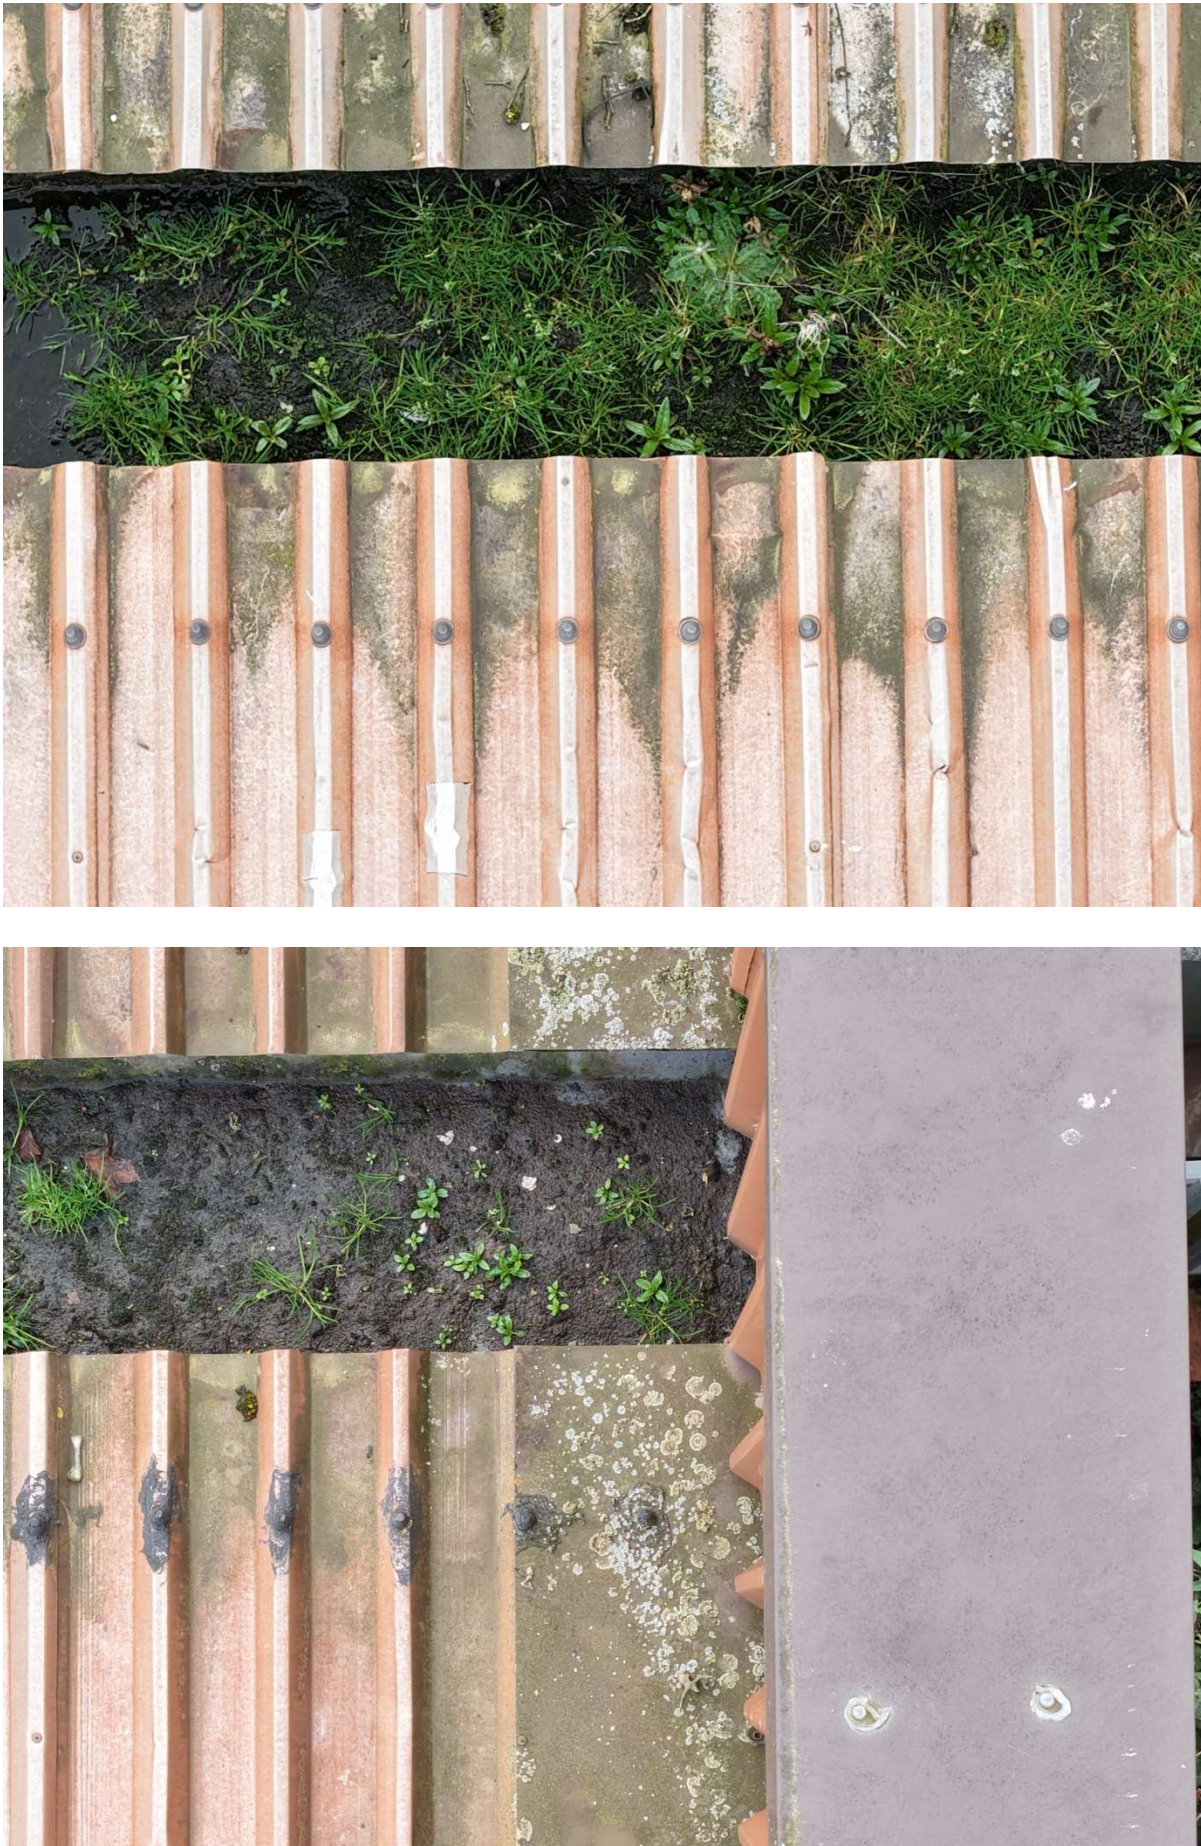
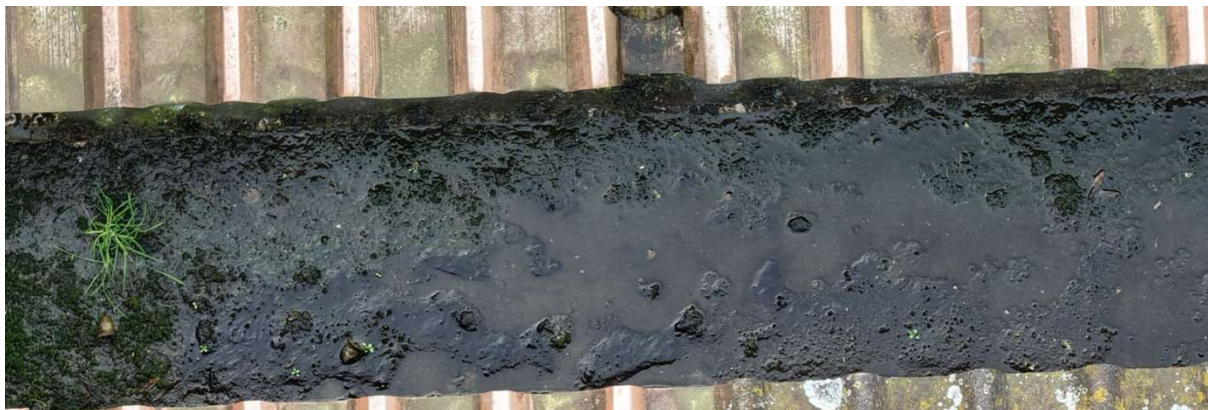
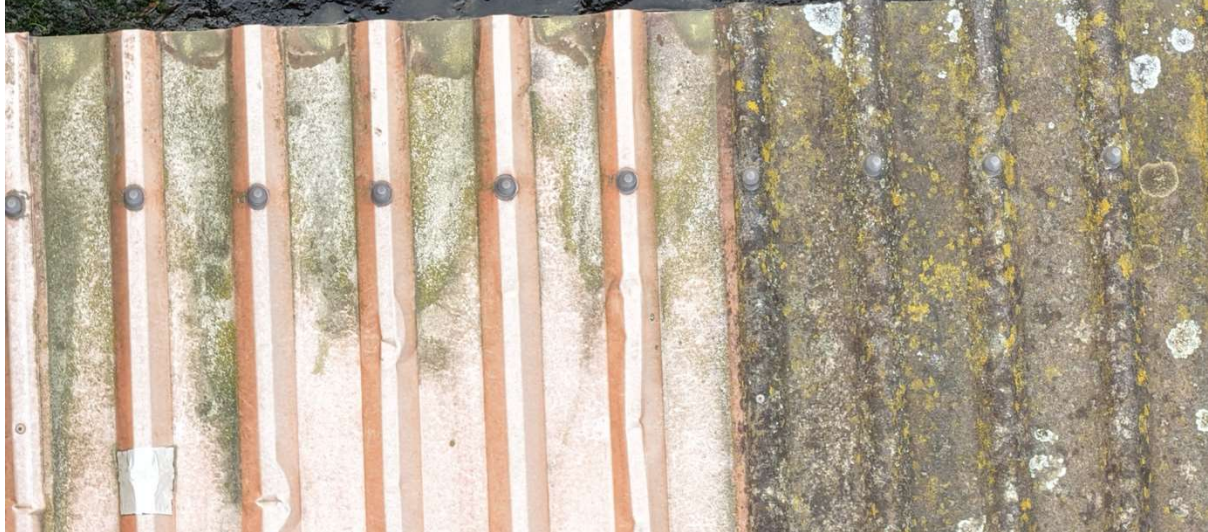
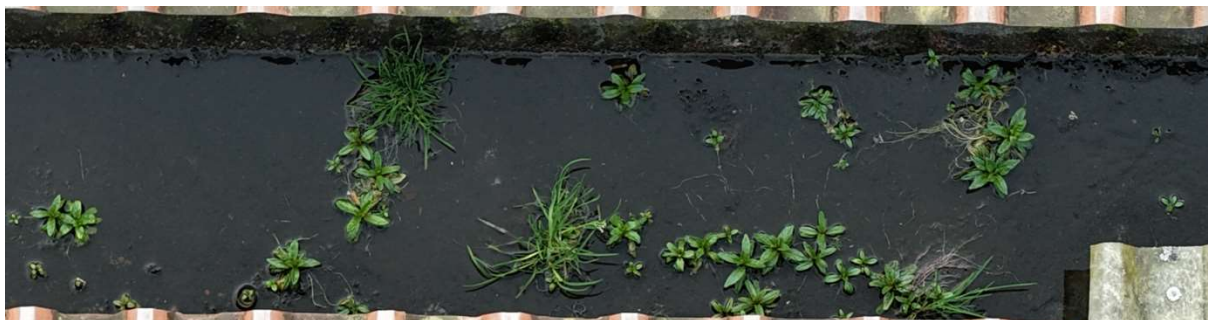
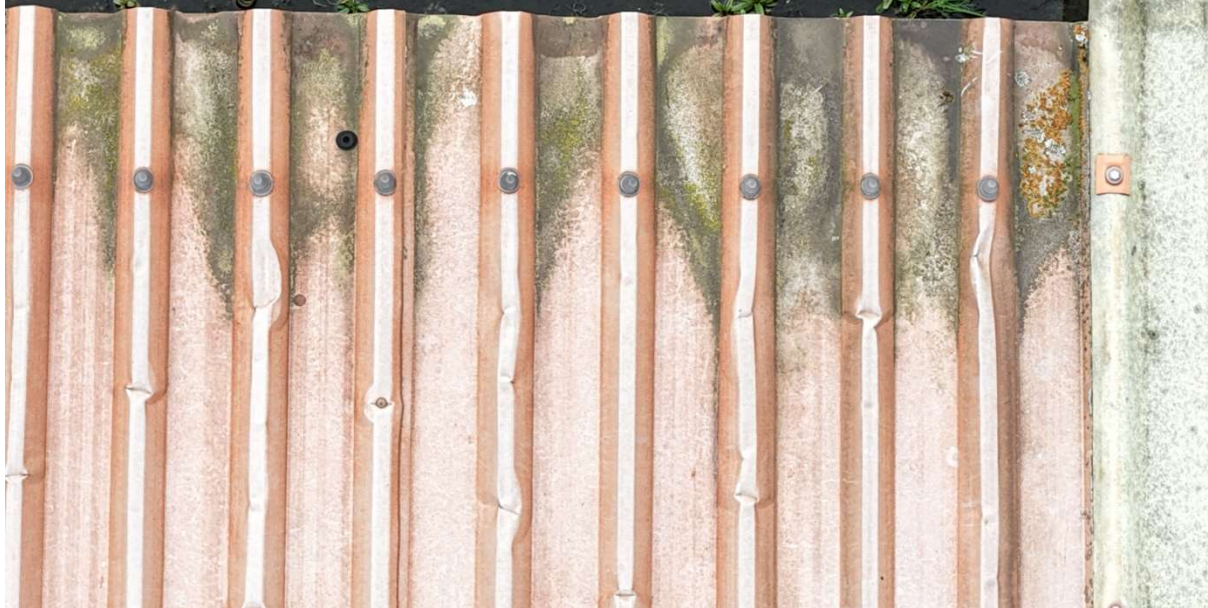
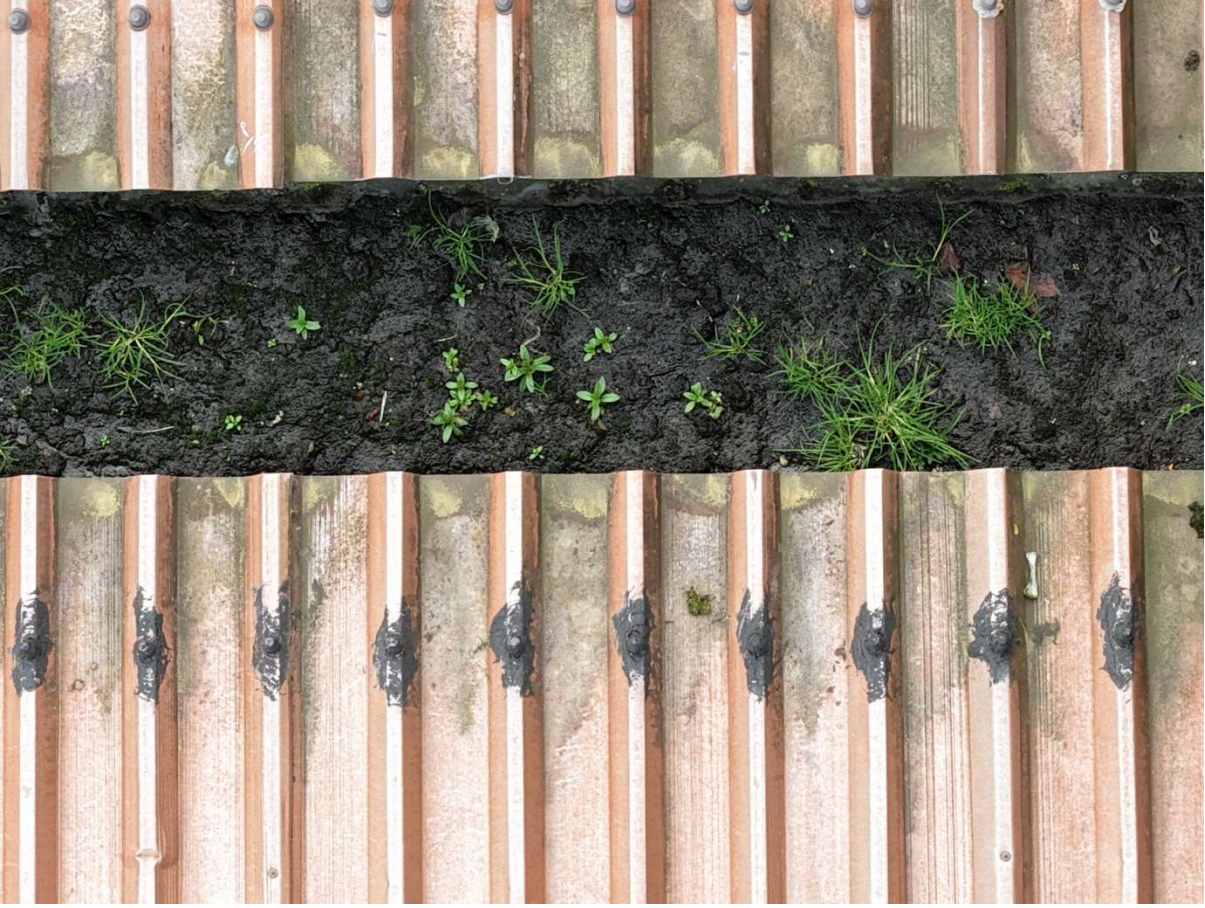
VALLEY JOINT – PRIMARY DEFECT

- Blocked with debris and vegetation
- Holding standing water
- Preventing adequate drainage

- Capillary backflow
- Lap joint saturation
- Internal ingress probability

The inter-unit valley joint exhibits significant debris accumulation and standing water, creating prolonged ponding conditions. This materially increases the probability of capillary backflow beneath sheet laps and accelerates corrosion progression.

Standing water observed across valley width indicating restricted drainage and prolonged moisture retention. Obstructed valley joint between roof pitches showing significant debris accumulation along full channel length.

- Clear valley to exposed liner
- Verify drainage fall
- Reflash Zone D exhaust
- Replace damaged internal materials

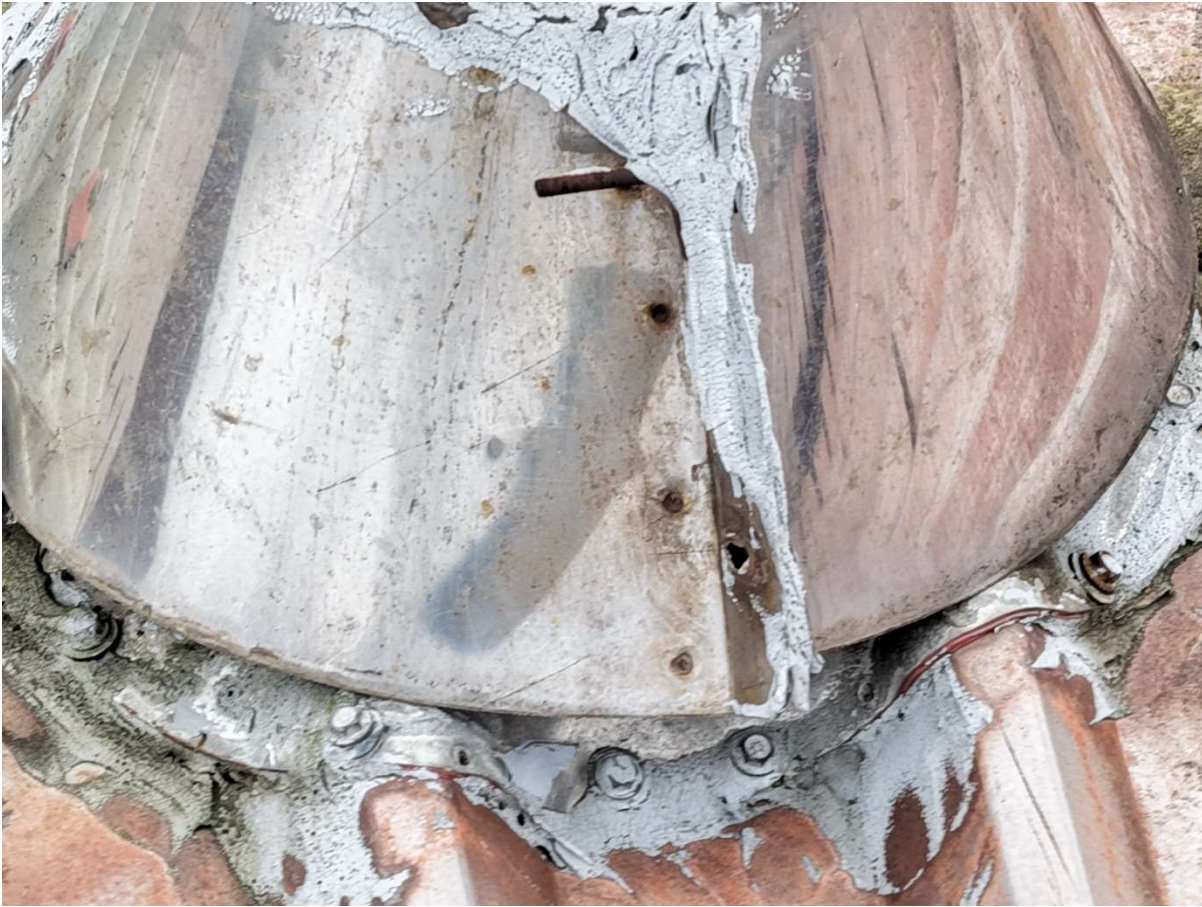
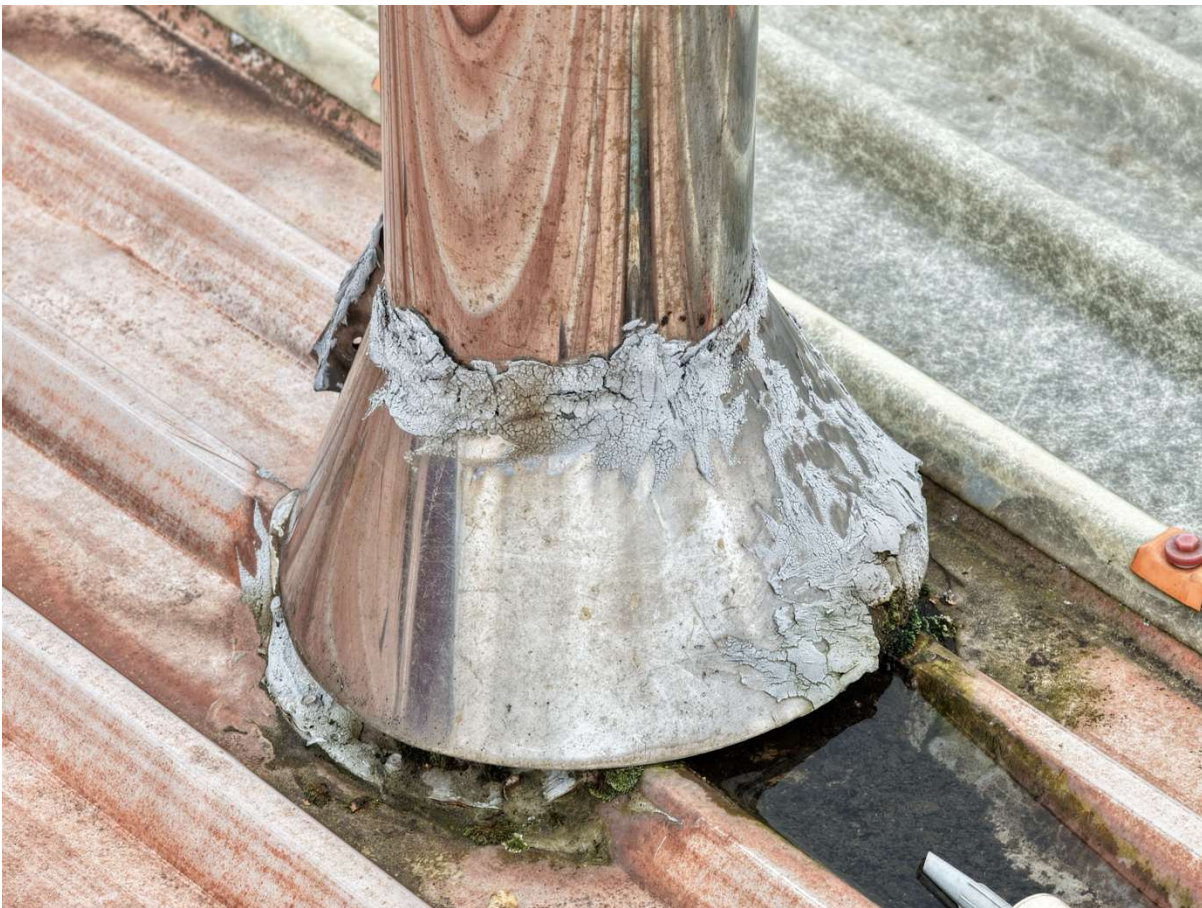
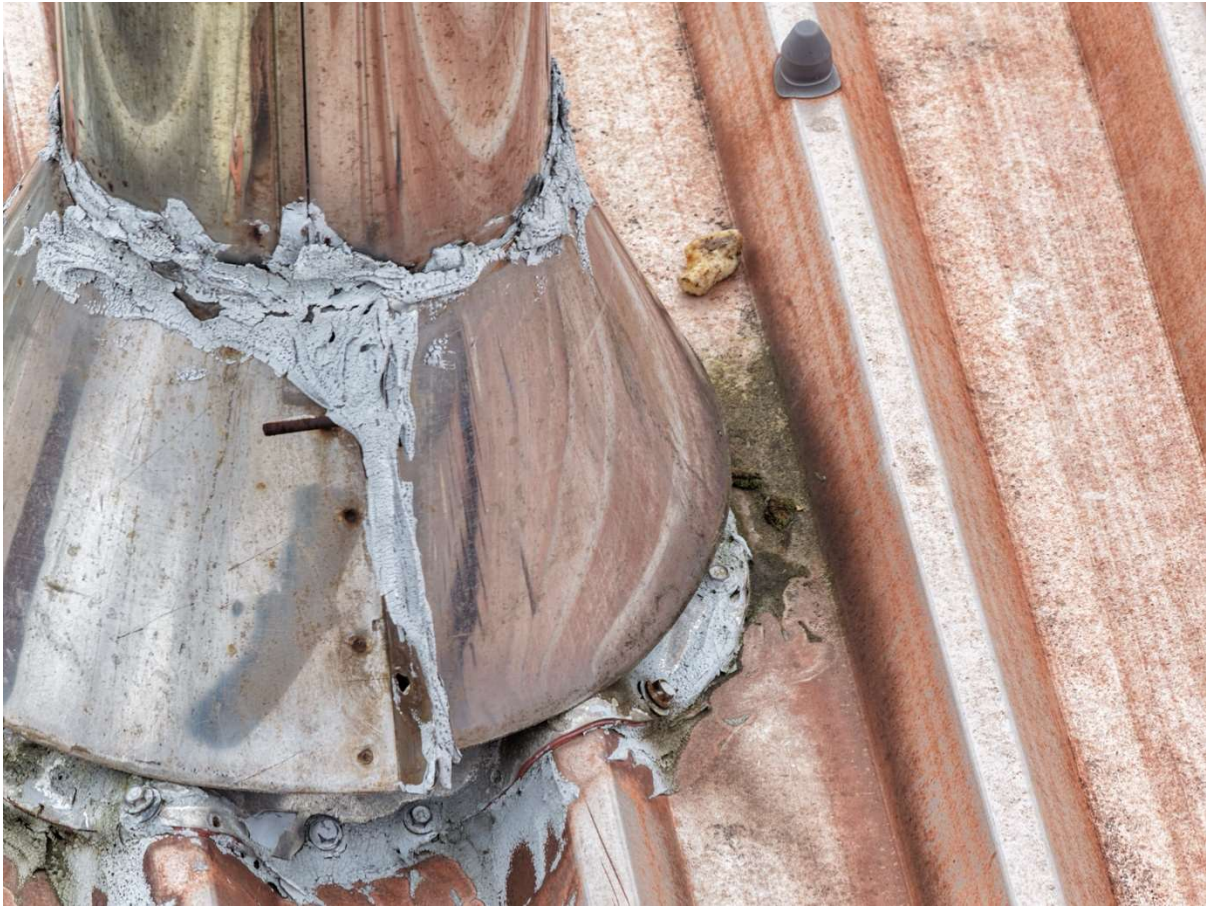
ZONE D – EXHAUST PENETRATION

- Failed exhaust penetration flashing
- Cracked mastic
- Corrosion perforation risk

Zone D exhaust penetration displays visible flashing degradation and historic patch repairs, presenting a high likelihood of direct water ingress during rainfall events.

Localized corrosion evident at flashing base indicating prolonged moisture exposure
Deteriorated sealant and historic patch repair visible at penetration interface

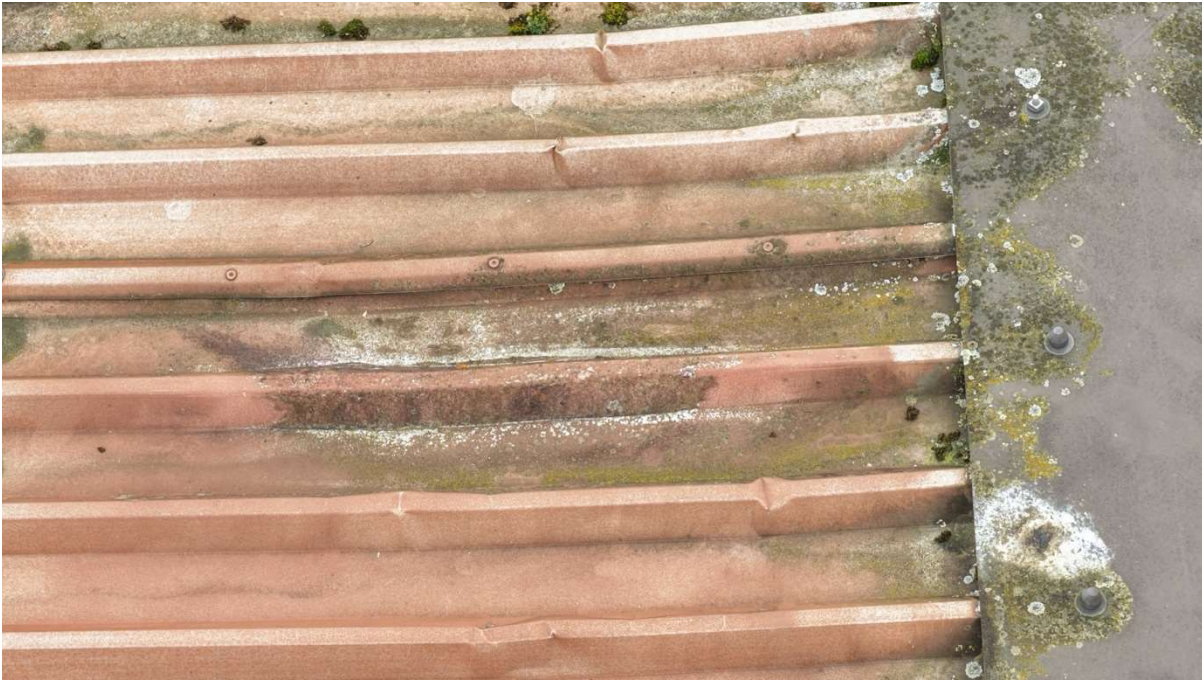
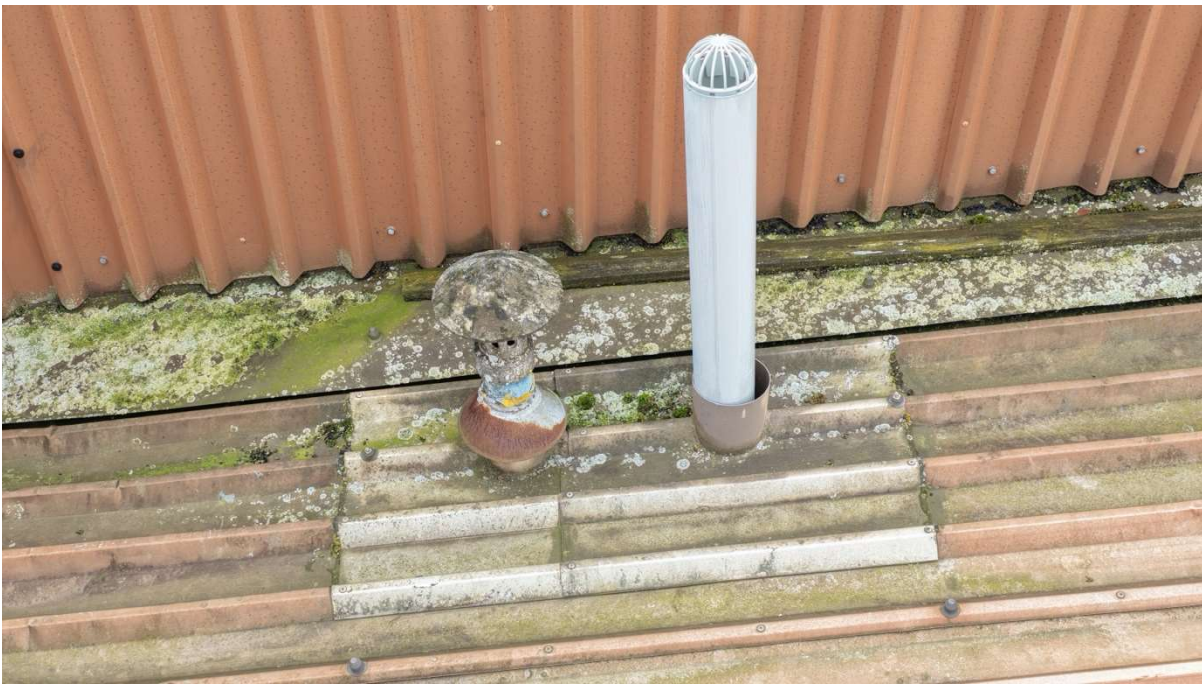
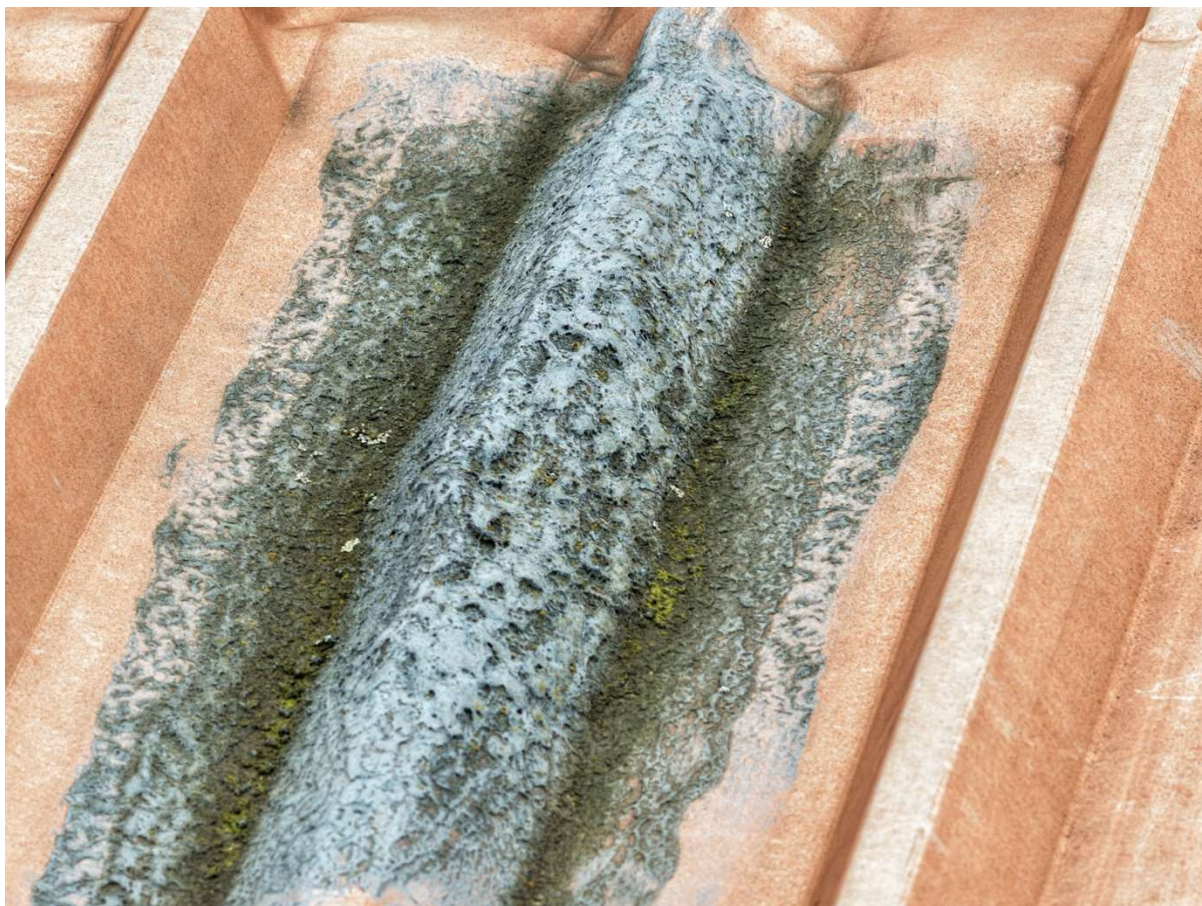
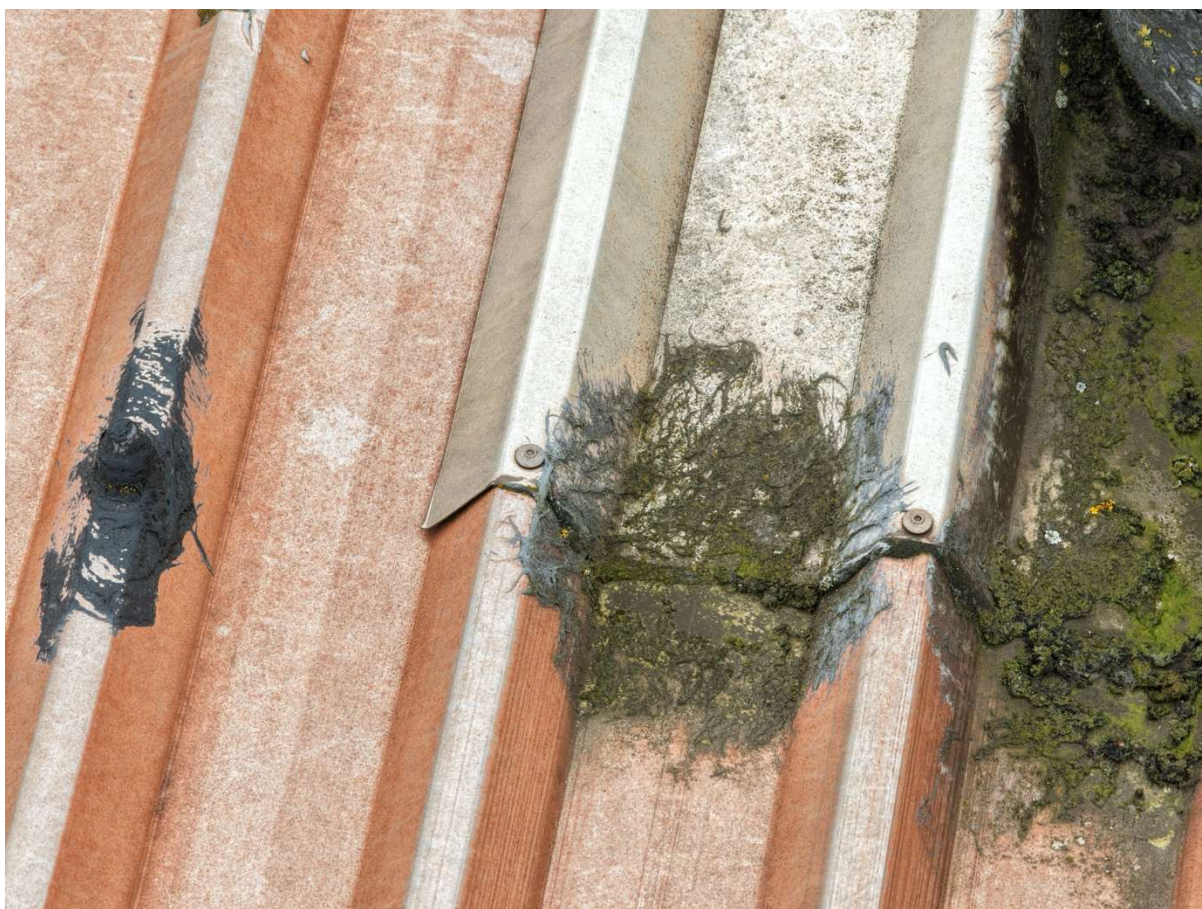
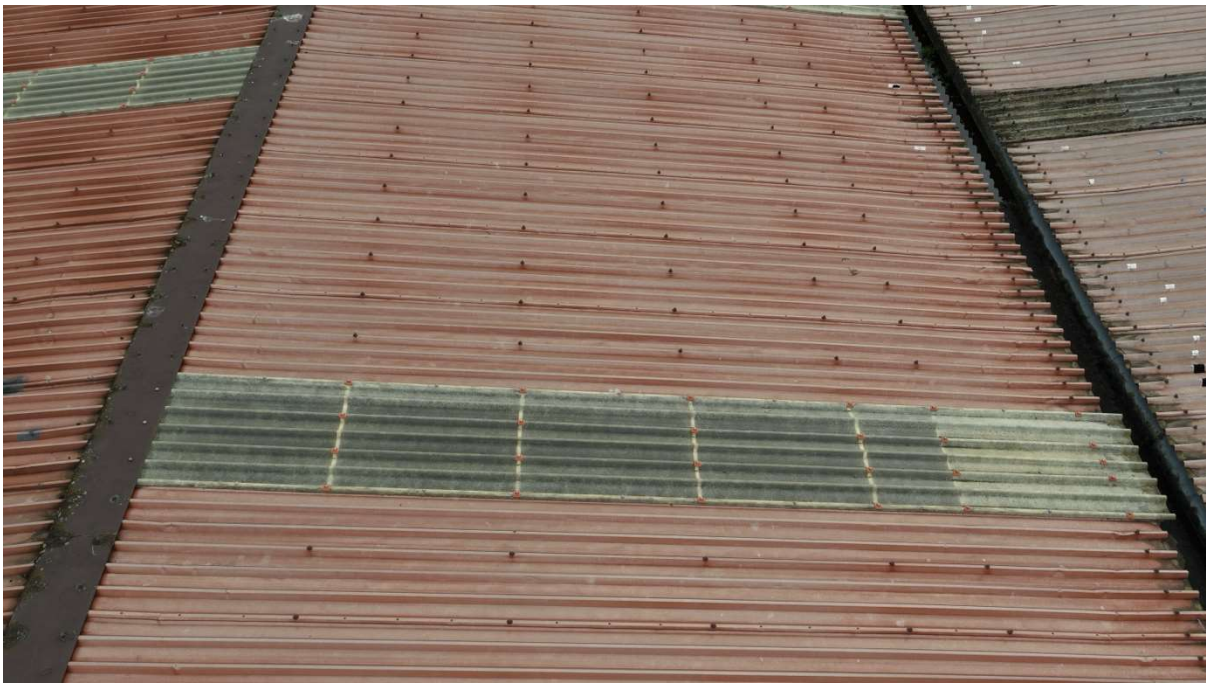
ZONES A B C – PROGRESSIVE DETERIORATION

- Vent penetration seal shrinkage
- Corrosion at fixings
- Early lap degradation

- Organic contamination at lap joints
- Sealant fatigue
- Increased capillary backflow potential

Progressive deterioration across Zones B and C, including sealant shrinkage and fastener corrosion, indicates ageing of the roof envelope beyond routine maintenance condition.

- Reseal penetrations
- Replace degraded fasteners
- Clean sheet laps
- 6-month follow-up inspection

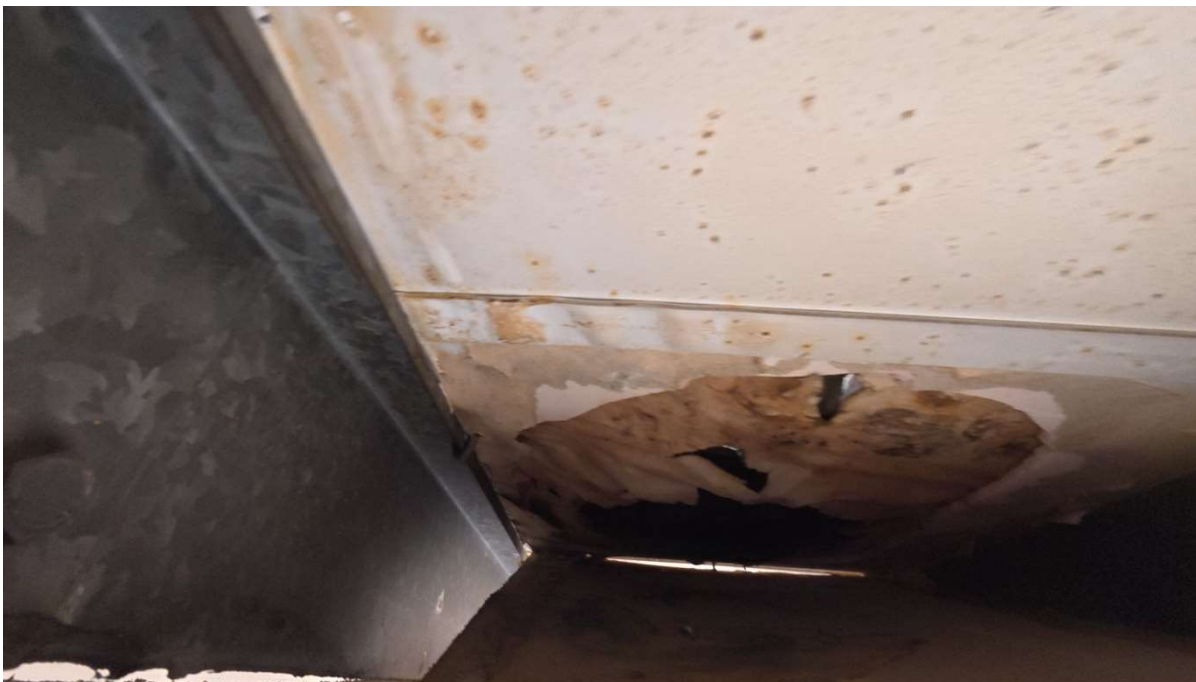
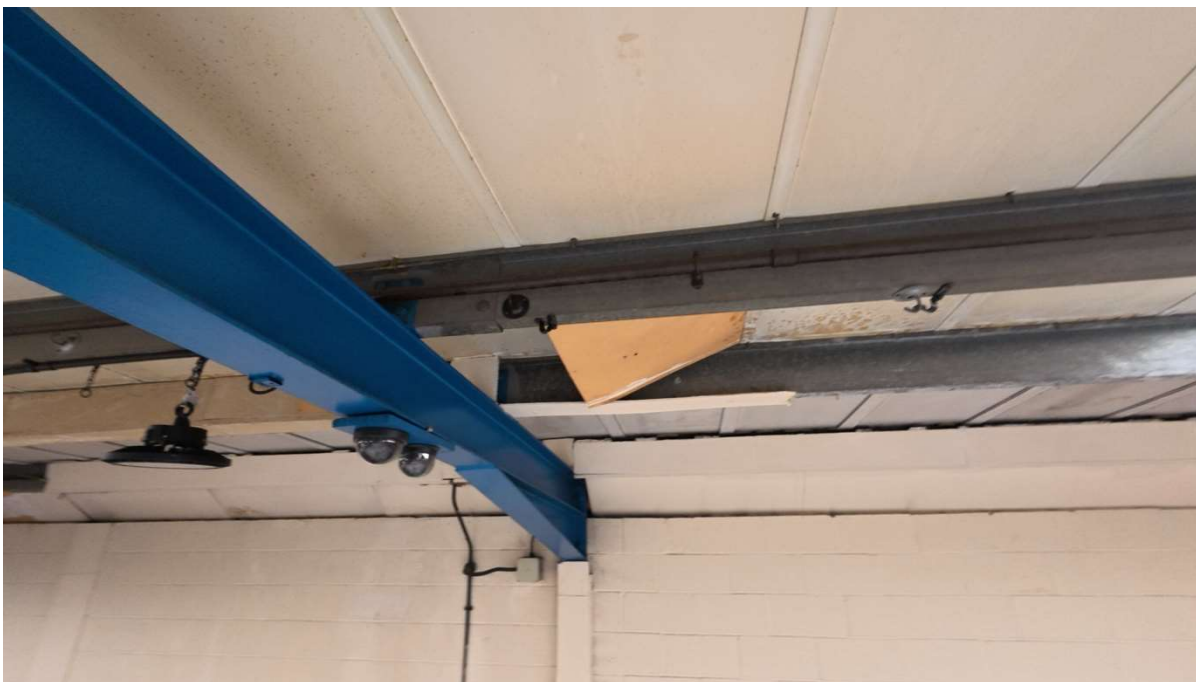
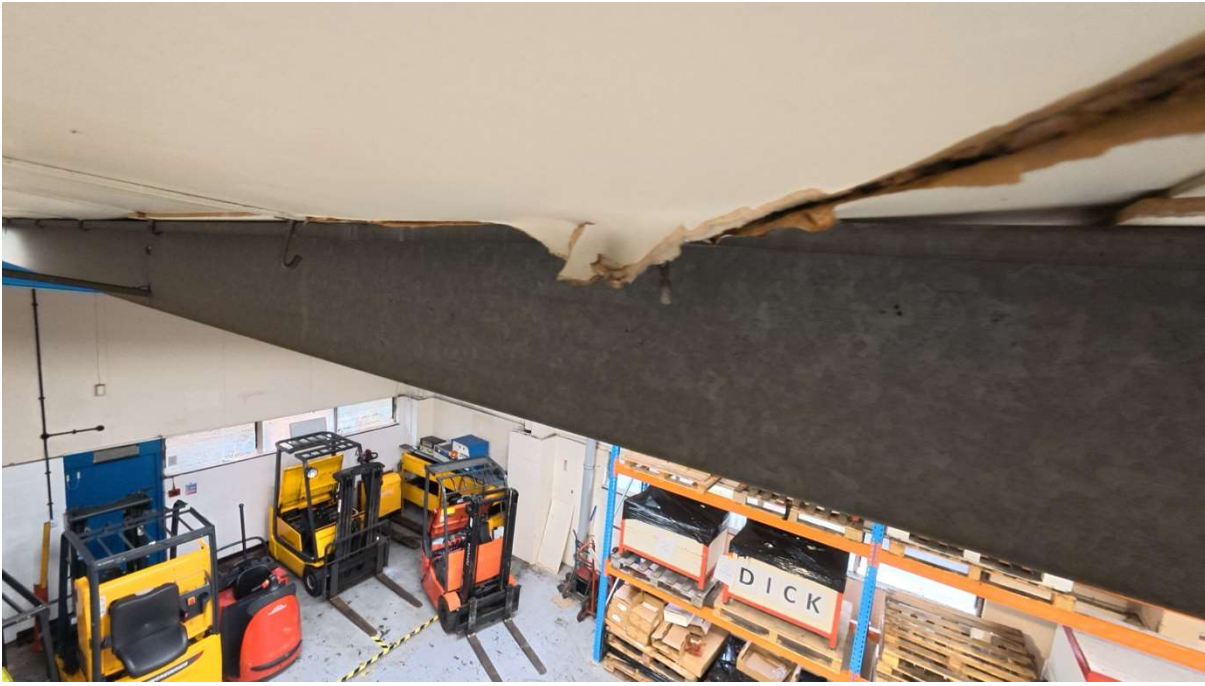
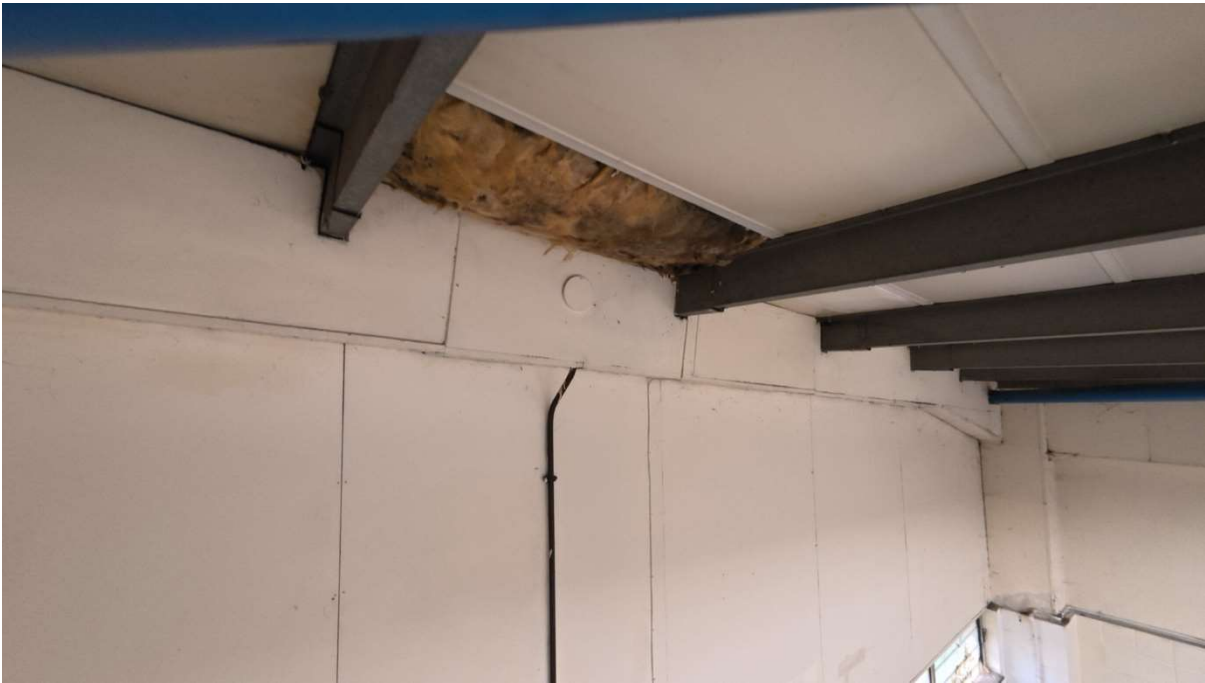
INTERNAL DAMAGE (DJI Action 5 PRO)

- Ceiling panel collapse
- Saturated insulation
- Water tracking along steel members

Damage aligns vertically with the valley joint and Zone D penetration.

Internal photographic evidence confirms ceiling collapse and insulation saturation directly aligned with the valley joint and penetration defects, validating that ingress has already occurred.

Collapsed ceiling section consistent with prolonged water ingress.

Exposed Insulation exhibiting moisture saturation and material degradation.
